2 SUGAR HOLLOW LAKE DAM,  
4 WARREN COUNTY, MISSOURI .  
MO 30522

# PHASE 1 INSPECTION REPORT NATIONAL DAM SAFETY PROGRAM.

SUBJECT: Sugar Hollow Lake Dam, MO 30522, Phase I Inspection Report

Name of Dam:	Sugar Hollow Lake Dam
State Located:	Missouri
County Located:	Warren
Stream:	Tributary of Wolf Creek
Date of Inspection:	20 May 1980

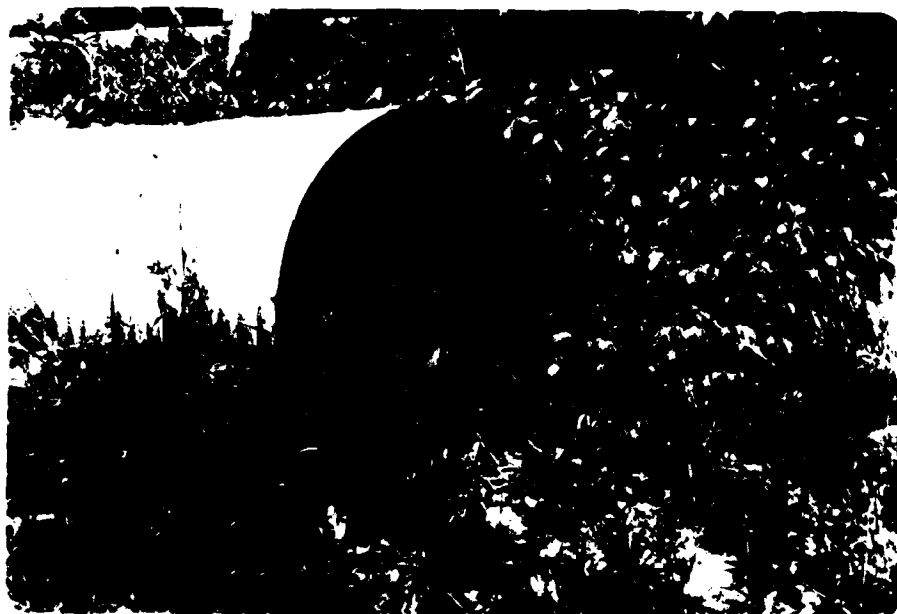
The upstream and downstream ends of the 42-inch diameter auxiliary spillway (see Photos 4 and 5) were examined and both appeared to be in good condition, although a small mound of earth on the order of 10 inches high partially blocked the pipe opening at the upstream end. The outlet channel for the auxiliary spillway (see Photo 6), with the exception of several small trees that were noticed near the downstream end of the channel, was also found to be in good condition.

NO. 4: UPSTREAM END OF AUXILIARY SPILLWAY LIDE

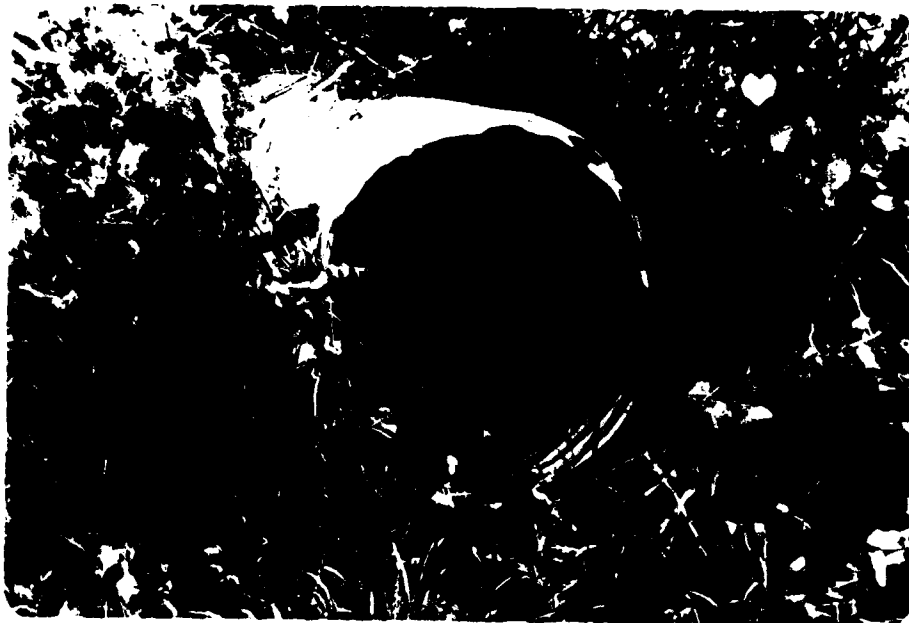
NO. 5: DOWNSTREAM END OF AUXILIARY SPILLWAY PIPE

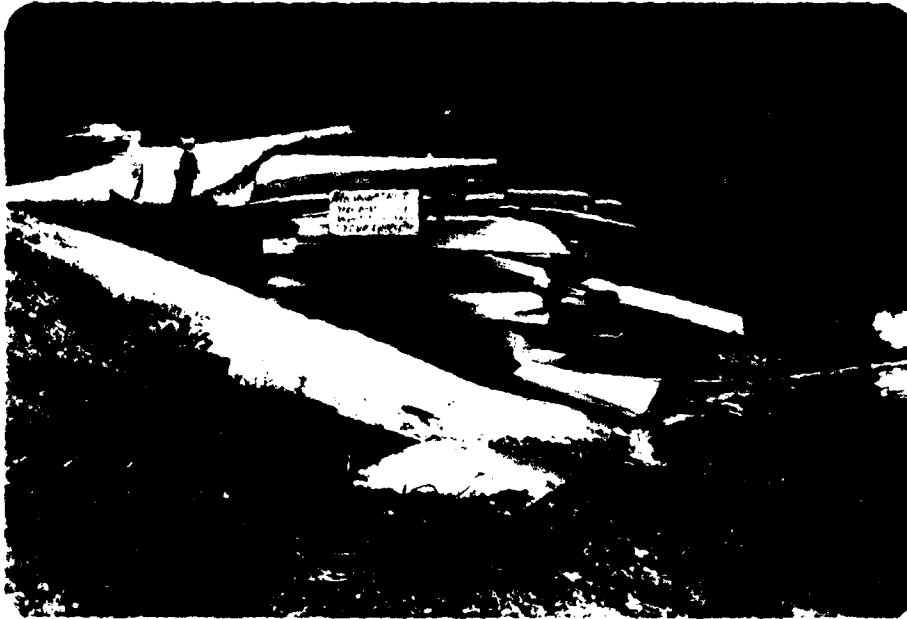
6. Debris, consisting of a sheet of plywood, several large boards, and logs were found along the upstream face of the dam. Numerous boats were also stored in and about a boat rack located on the upstream face of the dam. The possibility exists that debris as well as unsecured boats could, during high water, clog or partially clog the opening of the drop inlet spillway and negate its effectiveness.

NO. 11: DEBRIS AND BOATS AT UPSTREAM FACE OF DAM

(6) Remove the large items of debris (plywood, boards, logs) from the upstream face of the dam. Floating objects including boats can clog or partially clog the drop inlet spillway opening and negate its effectiveness. It is recommended that the Owner take whatever measures necessary to insure that all boats are secured to their moorings to eliminate the possibility of floating free while unattended during high water.
